# D4.1.1: Building renovation and supervision in Serres

**Lead Beneficiary – Municipality of Serres**

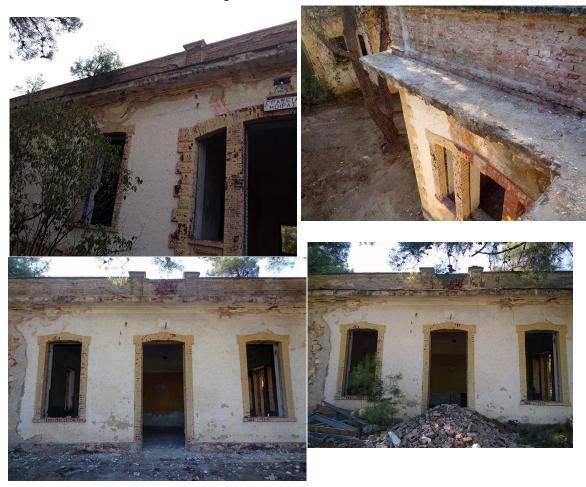
Demolitions of exterior coatings

The individual architectural elements of the building show significant, but local dismantling and collapse of the exterior coatings, alterations of the decorative elements and significant damage to the elements of the frames.

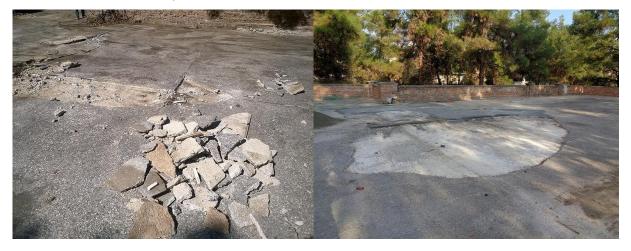
• Removal of destroyed areas of the roof

The most important of these issues was the concrete slab of the roof which had been dismantled in parts and its steel reinforcement had been stripped, mainly due to the effect of moisture.

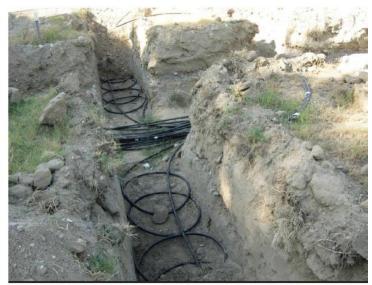
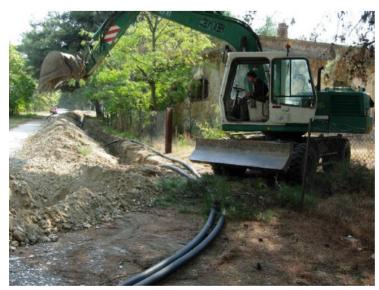
Installation of ground heat exchangers

It is a near zero energy consumption building, well-insulated, using geothermal energy for heating and cooling.
