WATER RESCUE

Water resources efficiency and conservative use in drinking water supply systems

WP	3 Current Status Analysis and Assessment
Deliverable	3.5.3 Water Quality report
<i>Tool</i>	<i>Joint Deliverable</i>
Sub-Deliverables integrated	D.3.1.3, D.3.2.3, D.3.3.3, D.3.4.3, D.3.5.3, D.3.6.3
Project Beneficiary	PB5
No	
Beneficiary Institution	Municipality of Gotse Delchev

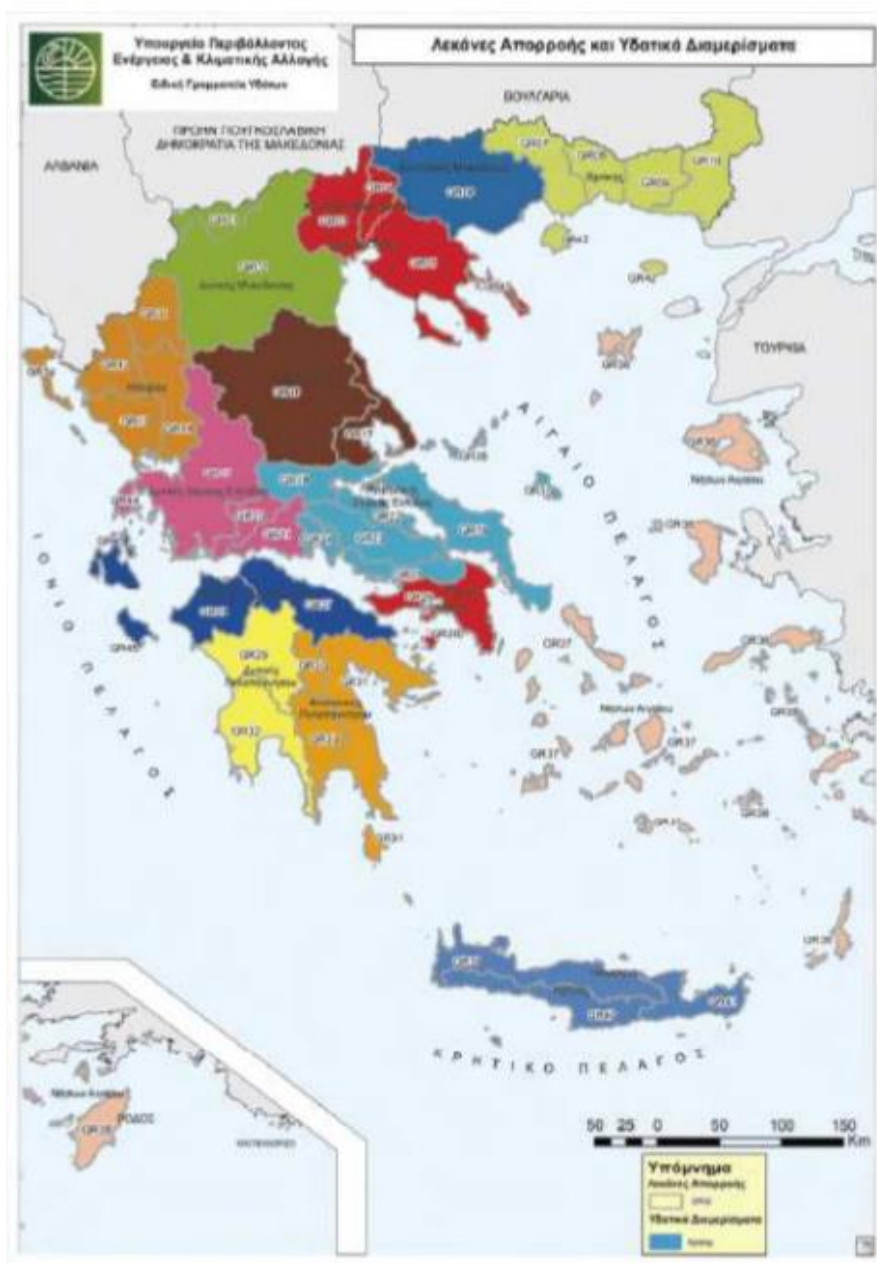
Figure 1. Water Districts in Greece (source RBMPs)

The University of Thessaly reports the current status analysis regarding water resources quality at national level. Greece consists of 14 Water Districts (WDs) (Figure 1).

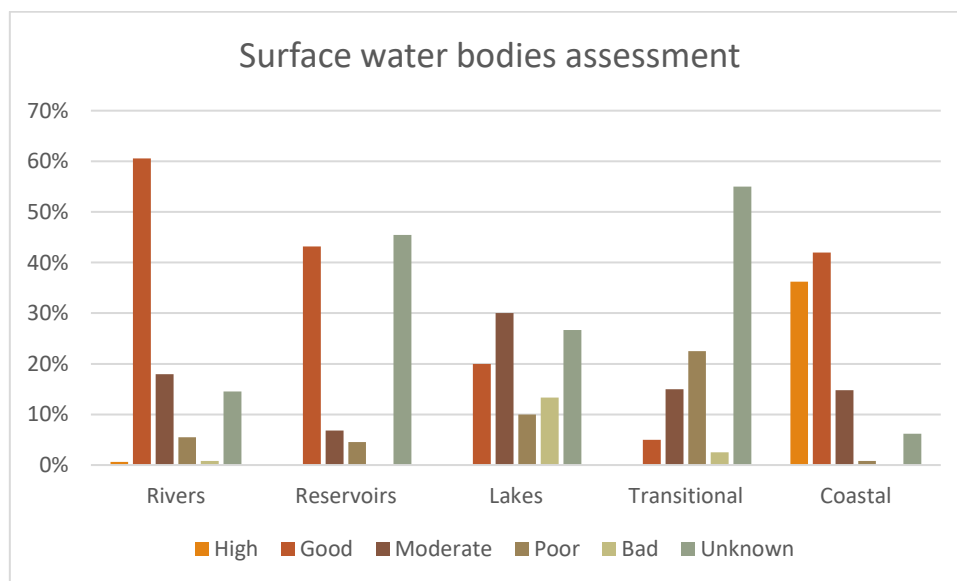
Figure 2. Surface water bodies qualitative assessment (data gathered from the RBMPs, 2017)

The results showed that the majority of the rivers are found in good qualitative status (60.6%), while only 17.9% are found in moderate status and 14.5% in unknown status (Figure 2). The majority of the reservoirs are found to have an unknown qualitative status (45.5%) while 43.2% of them are found to be in good qualitative status. The majority of the lakes are found in be in moderate status (30%) and 20% of them in good status, while 26.67% of them are classified as unknown qualitative status (Figure 2). Transitional water bodies have unknown qualitative status (55%) while 22.5% of them are found to be in poor status. Finally, coastal water bodies have good qualitative status (41.2%) and high qualitative status (36.2%) (Figure 2).

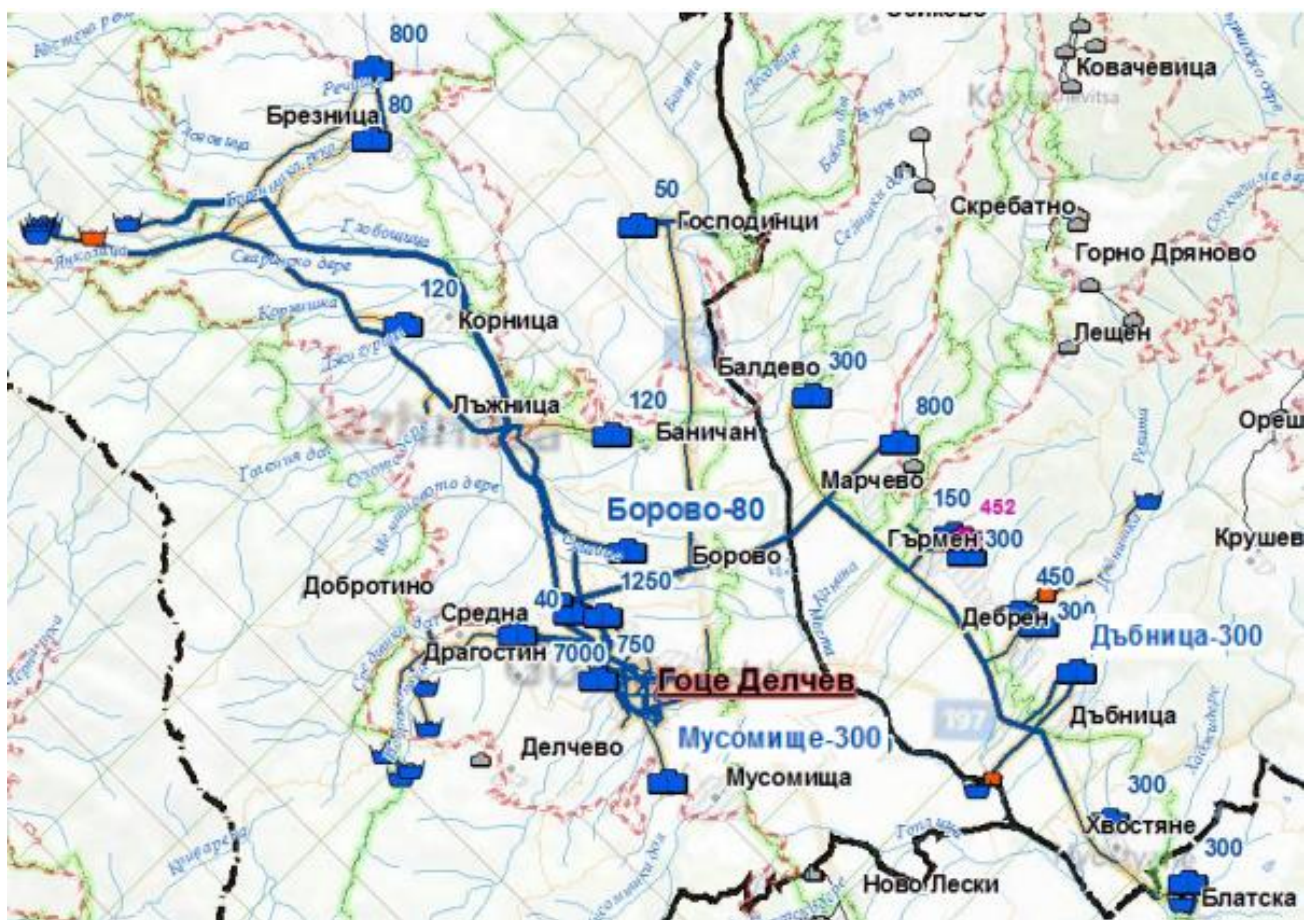
Scheme 2 – water reservoirs on the territory of WSS Gotse Delchev

On the territory of water supply system of Gotse Delchev 20 reservoirs are used to store water needed for efficient water supply. Three of the reservoirs are used for the water supply of Gotse Delchev – $V=7000$ m³; $V=1250$ m³; $V=750$ m³. Rest reservoirs are used for following settlements – Musomishte $V=300$ m³; Borovo $V=80$ m³; Banichan $V=120$ m³; Kornica $V=120$ m³; Breznica $V=800$ m³ and $V=80$ m³; Gospodinци $V=50$ m³; Badlevo $V=300$ m³; Ognyanovo $V=800$ m³; Garmen $V=300$ m³ and $V=150$ m³; Debren $V=450$ m³ and $V=300$ m³; Dabnica $V=300$ m³; Hvostyane $V=300$ m³; Blatska $V=300$ m³.
