WATER RESCUE

Water resources efficiency and conservative use in drinking water supply systems

Deliverable

5.2.4 Ex Post Evaluation report

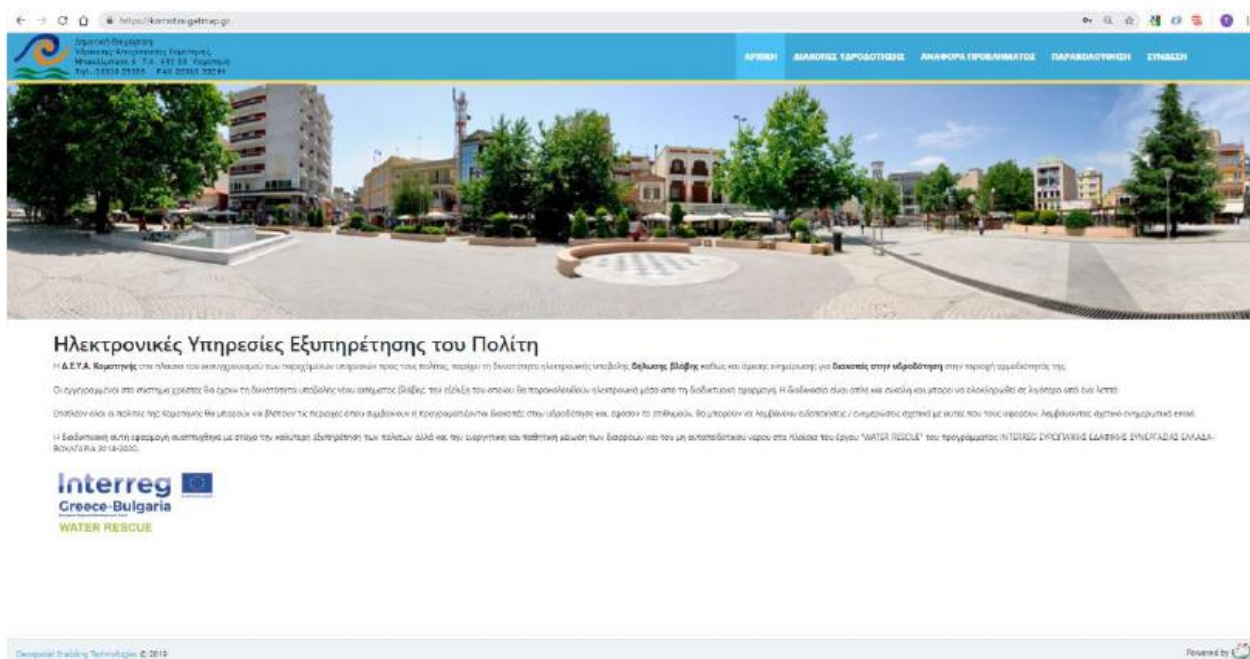
Figure 3.1.1. Application interface

The IT applications developed consist of applications for the public accessible at <https://komotini.getmap.gr/> (Figures 3.1.1) and spatial mapping of failures accessible at <https://deyakmap.getmap.gr> for the managers of the utility having full access (Figures 3.1.2, 3.1.3 & 3.1.4).

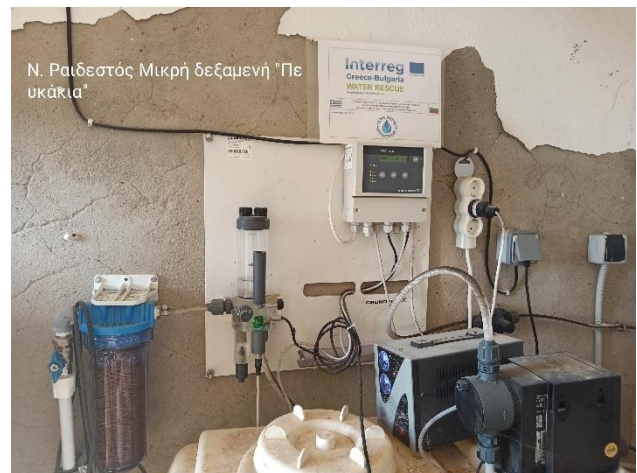
Figure 3.2.8. Map of boreholes and tanks in N. Redestos – tank Δ1 - Pefkalia (where automated chlorination system is installed) is shown in circle

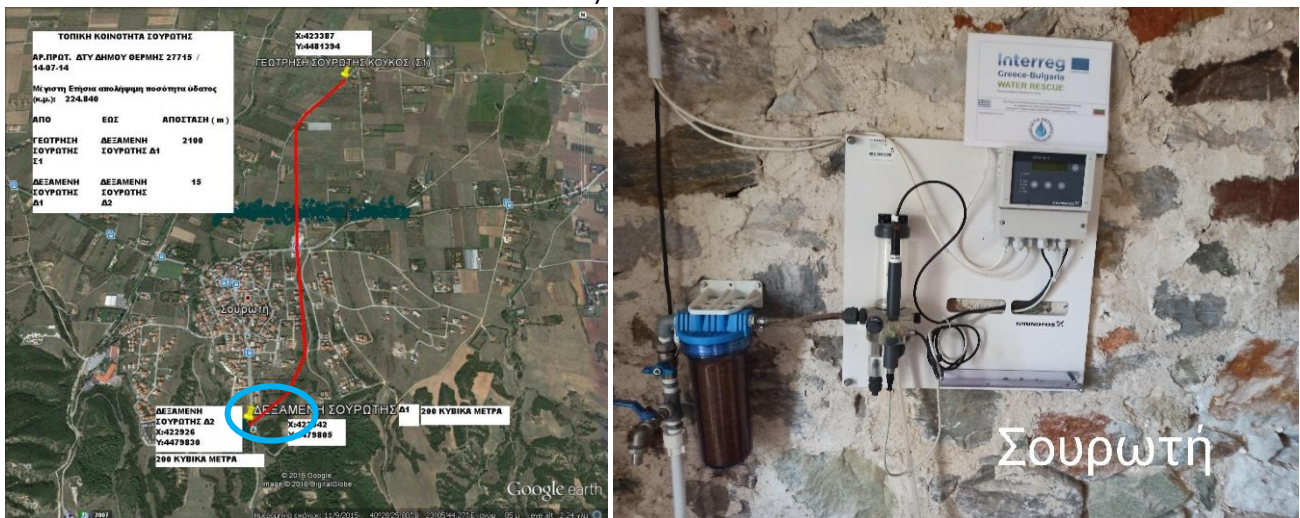
Figure 3.2.10. Map of boreholes and tanks in Souroti – tank Δ1 (where automated chlorination system is installed) is shown in circle

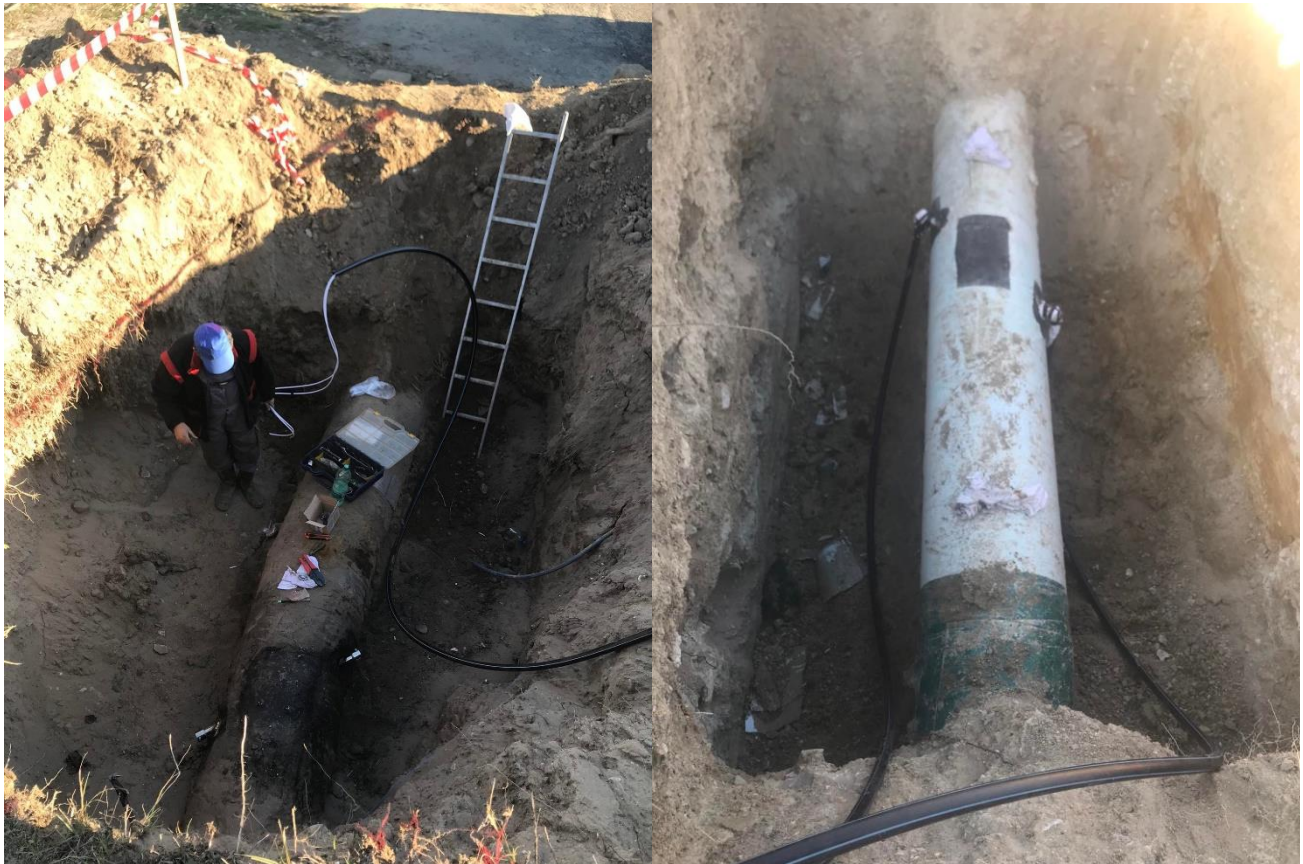
Figure 3.4.2. Installation of the flowmeters

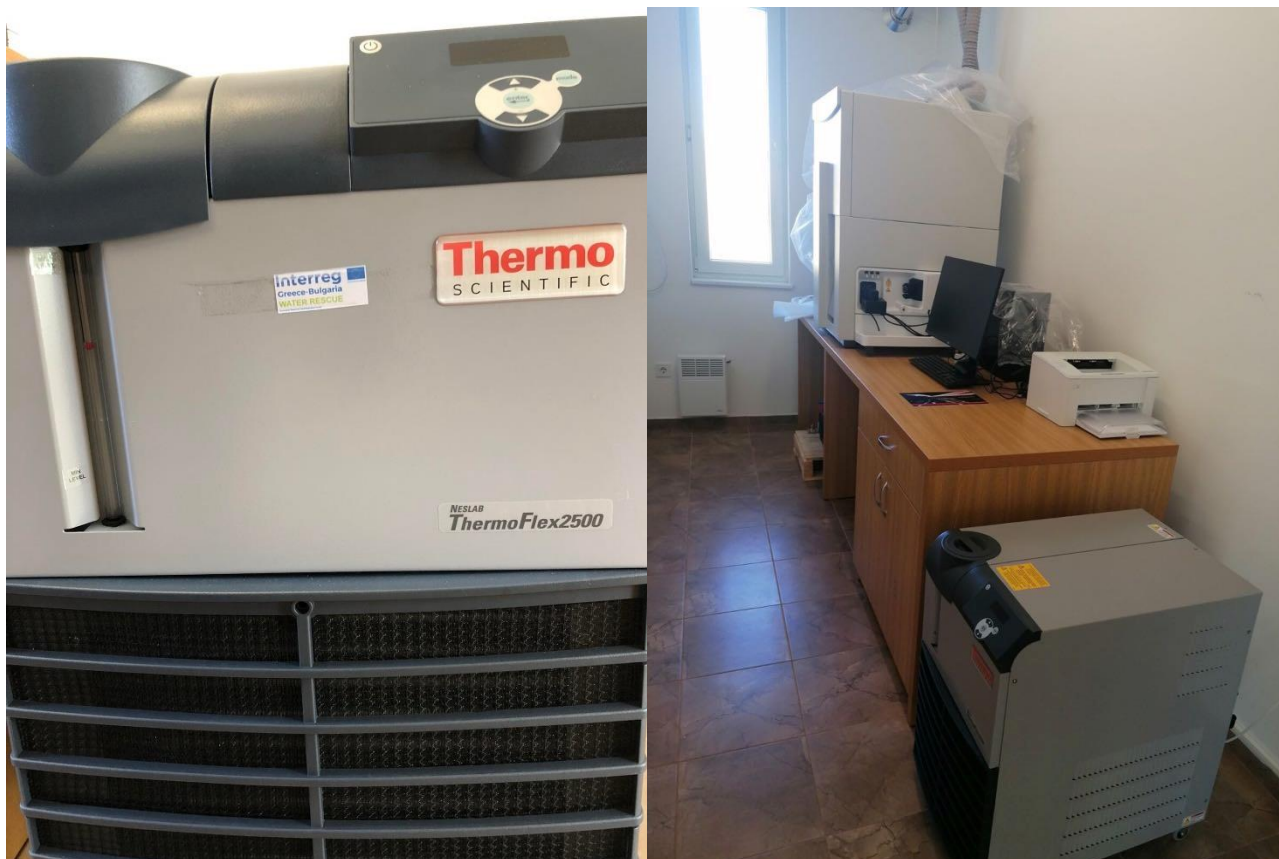
Figure 3.4.3. Mass spectrometer

On December 22, 2021, the mass spectrometer was installed, configured, tested and ready for operation (Figure 3.4.3). During the functional tests of the system, the following standard procedures were performed to check the qualification of the installation, operational readiness and verification of the equipment for operation.

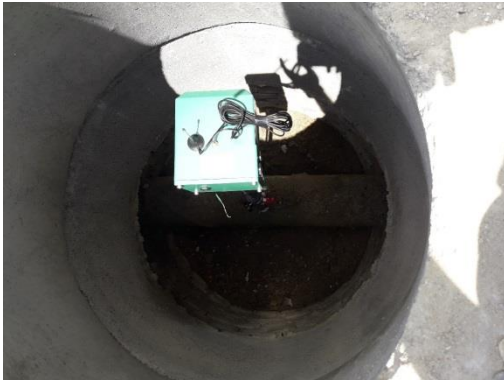
Figure 3.5.1 – manhole with insertion flow meter at the entrance of DMA Dunav

- Design of DMA, construction of a manhole, installation of measuring equipment and data analysis – as a part of that part of pilot actions insertion flow meter with autonomous power supply was supplied and installed. In addition data was implemented in specialized software for data management and water loss calculation.

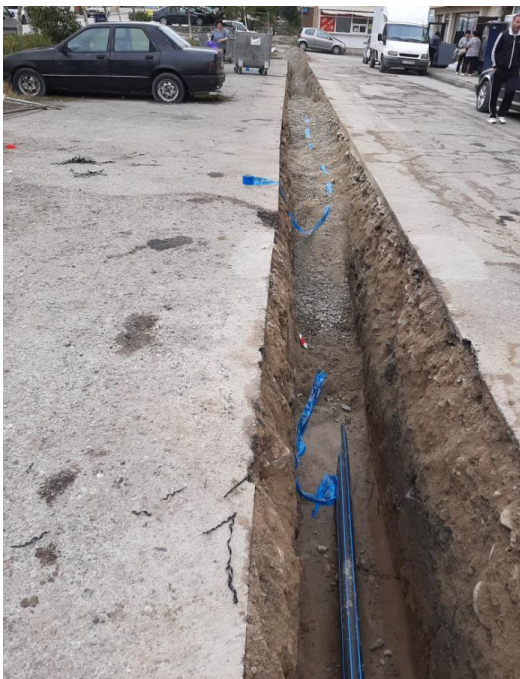
Figure 3.5.3 – Reconstruction of pipeline

- Rehabilitation of water main in DMA Dunav – final stage of the project was related with rehabilitation of certain pipe sections with following sizes and length:
 - $\Phi 110$ – 601 m
 - $\Phi 90$ – 552 m
 - $\Phi 63$ – 294 m

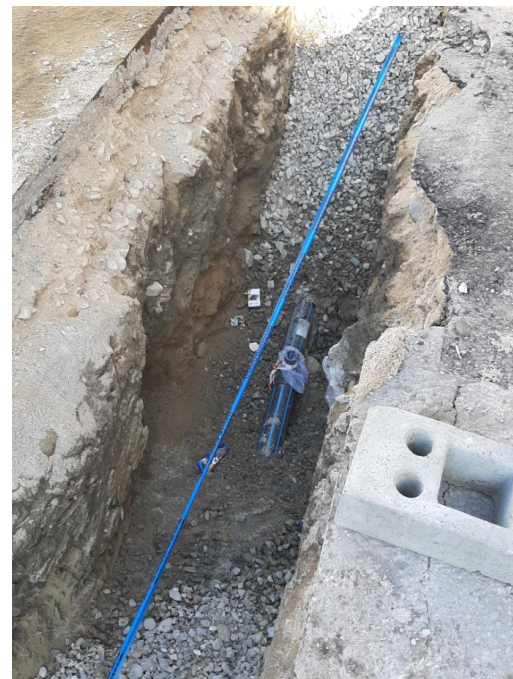
Figure 3.5.4 – Reconstruction of pipeline

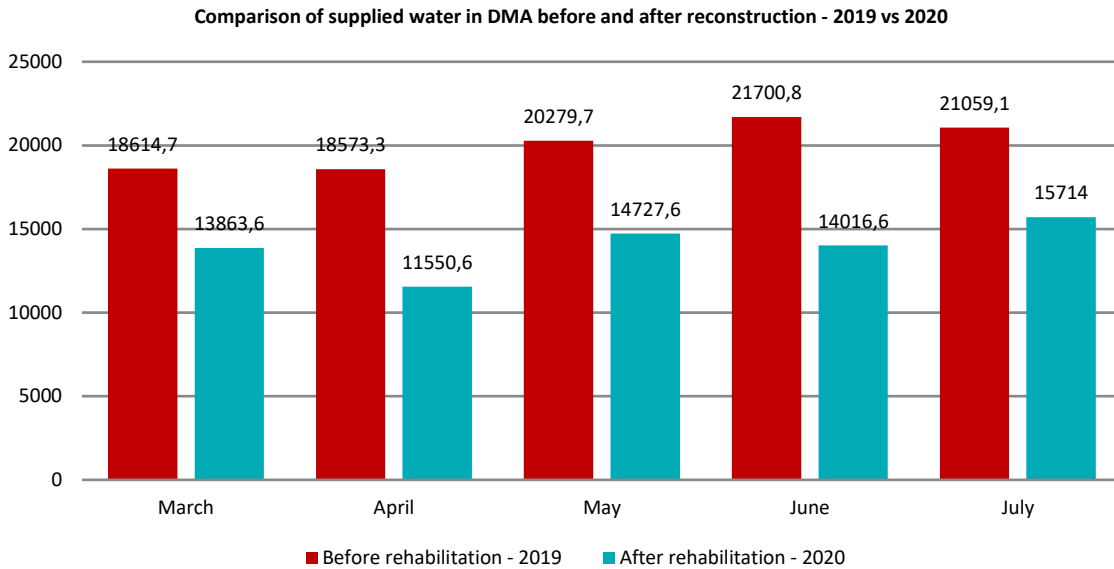
Figure 3.5.5. Water supplied in DMA before and after the implementation of the pilot action

The water supplied in the DMA is reduced after the pilot action implementation. Specifically, the reduction ranges from 25% (July) to 38% (April).

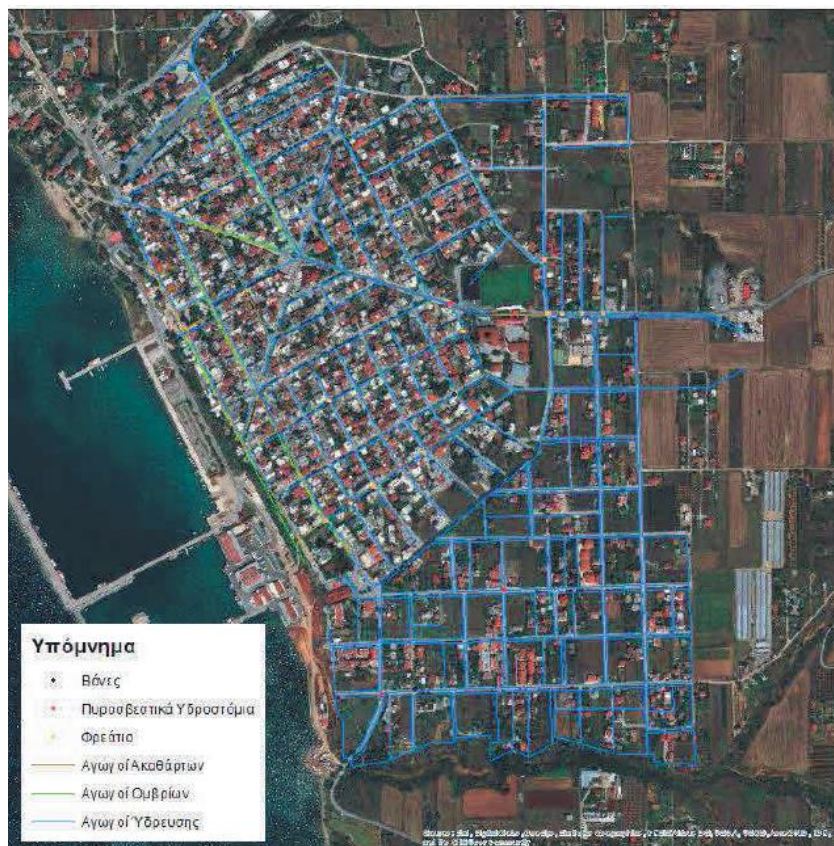
Figure 3.6.5. The water distribution network of New Mihaniona

The IT applications are developed for the water supply network of DEYA of Thermaikos, both internal (Figure 3.6.5 & 3.6.6) and external (Figure 3.6.7). The user has maps with the infrastructure of the water distribution network and at the same time can get information about any failures or water interruptions.

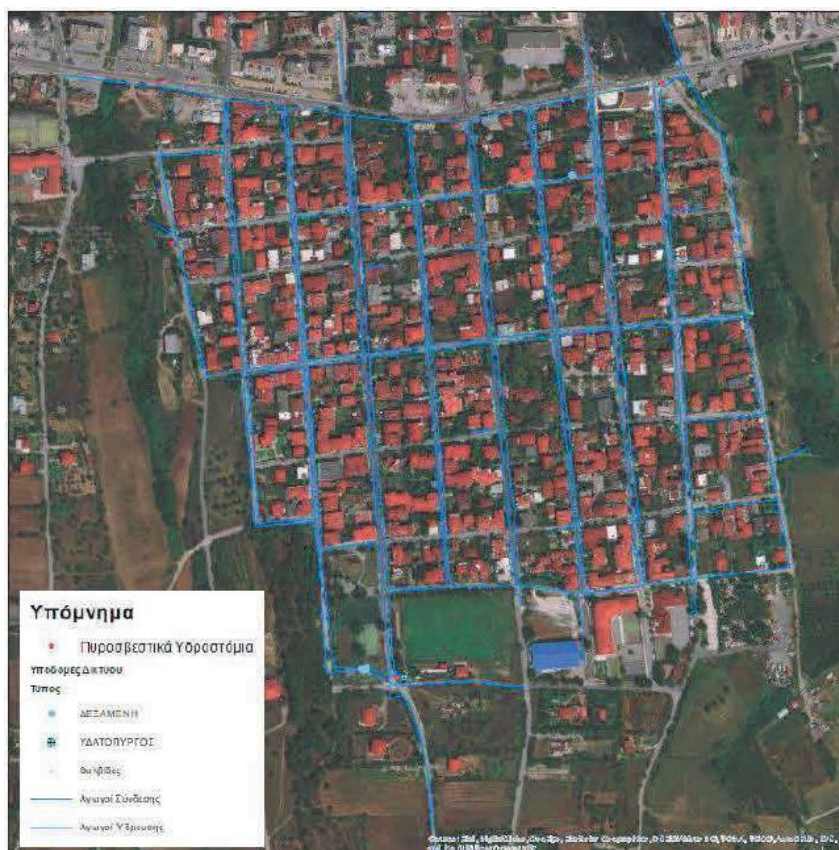
Figure 3.6.6. The water distribution network of Ano Peraia

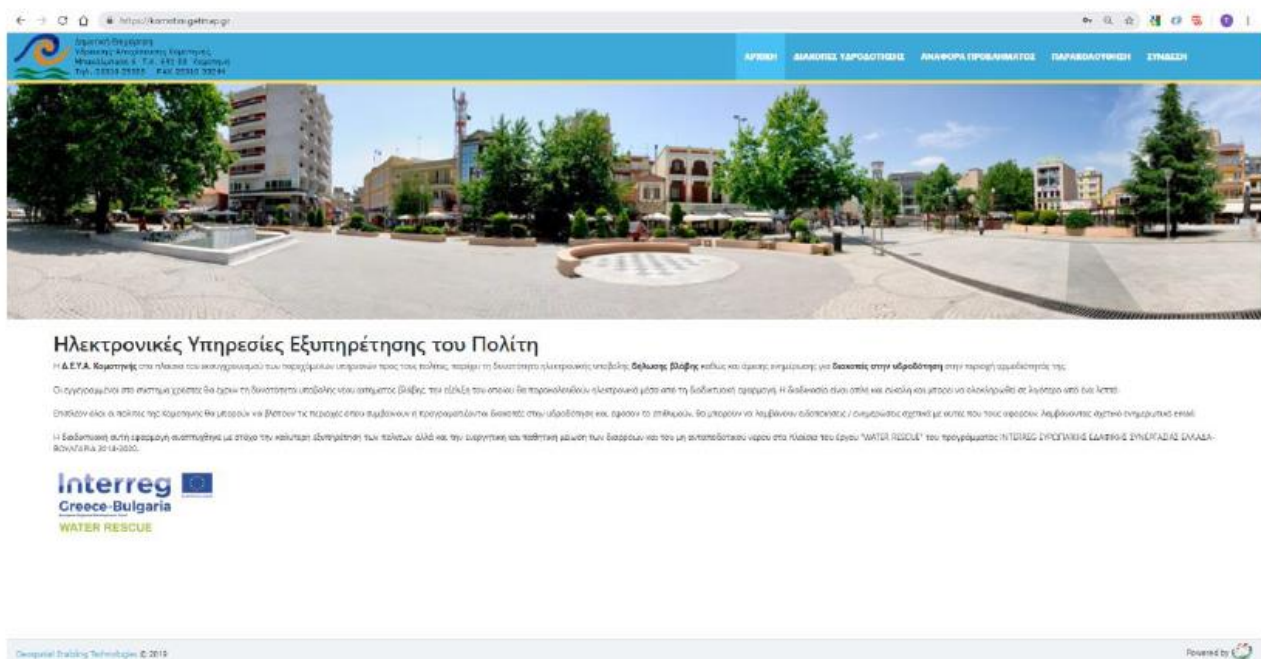
Figure 1. Application interface

The IT applications developed consist of applications for the public accessible at <https://komotini.getmap.gr/> (Figures 1) and spatial mapping of failures accessible at <https://deyakmap.getmap.gr> for the managers of the utility having full access (Figures 2, 3 & 4).

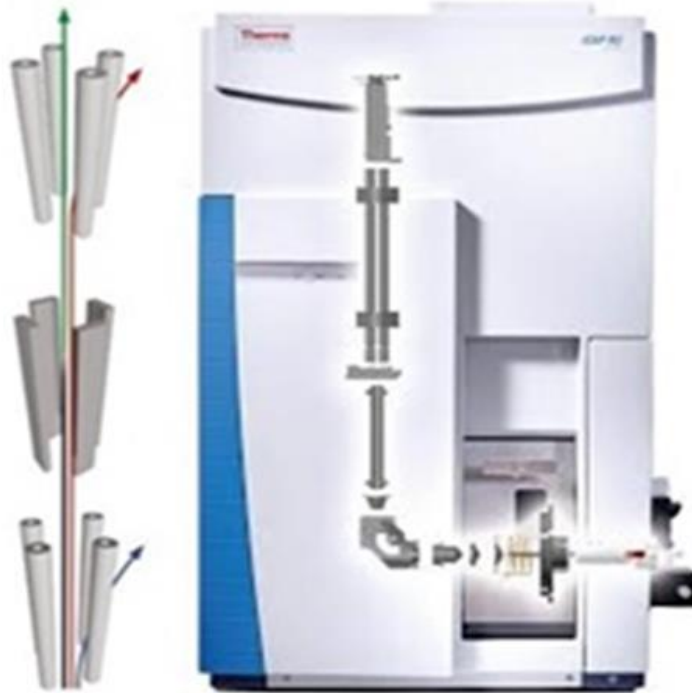
Delivery and installation of mass spectrometer with inductively connected plasma Plasma ICP - MS.
